Identification of Beach Erosion in Colombo- North Coast Line: Effectiveness of the Engineered Solutions

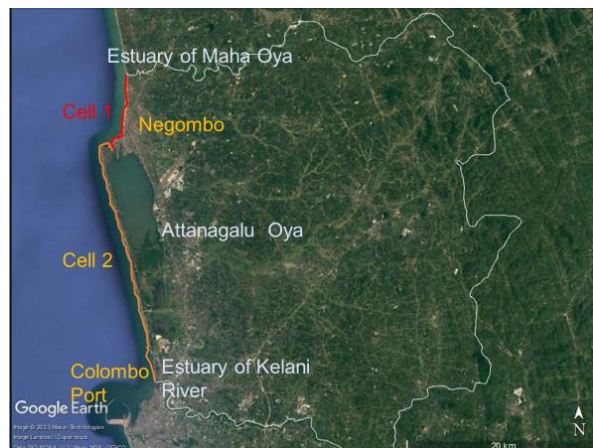
Figure 2: Geographical boundaries of the Gampaha district and relevant coastal area which is divided into 2 cells (Cell 1- From Estuary of Maha oya to Negombo lagoon, Cell 2- From Negombo lagoon to Estuary of Kelani river)

The Colombo- North coastline which is relevant to Gampaha district coastline (See figure 2) was selected as the study area of the case study as it is the coastline of the most populated district in SL as well as provide livelihoods and recreations for millions of people. Then the study area was divided into 2 cells.

- Cell1- Estuary of Maha Oya to Negombo Lagoon-8.05 km
- Cell 2- Negombo Lagoon to Estuary of Kelani River-28.5 km

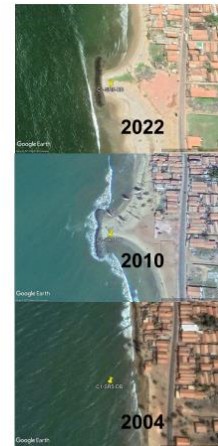
The figure 4 shows an example satellite image analysis and accordingly the structure has been constructed during 2004-2010 time period. Likewise, the evolution of the structures along the cell 1 and cell 2 conducted accordingly.

Figure 4: Satellite images analysis, to assess the construction period of structures.

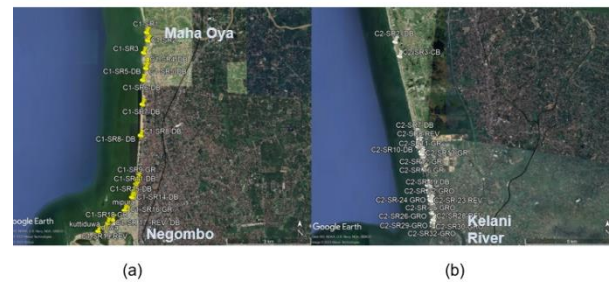
The figure 6 shows the existing structures which were mapped after analysis of the google satellite images. Approximately 54 structures were identified in the analysis.

Figure 6: (a) Observed structures in cell 1 at 12-2022- 19 Nos
(b) Observed structures in cell -2 at 12-2022-33 Nos

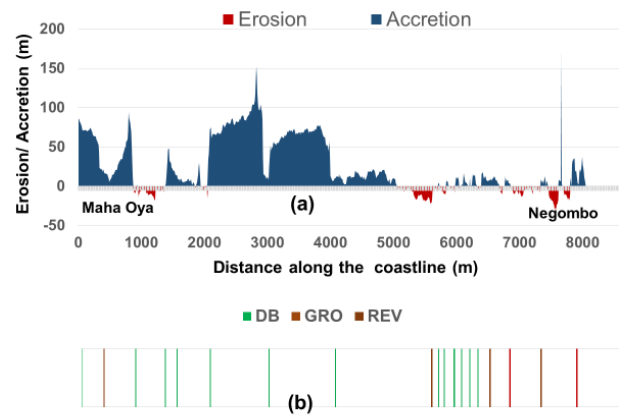
Figure 7: (a) Cell1-Net Shoreline Movement (NSM) from 2001-2022
(b) Types of structures along the cell 1

Figure 7 shows the results of digital shorelines analysis related to cell 1. As per the comprehensive analysis conducted using the Digital Shoreline Analysis System (DSAS), the assessment of Net Shoreline Movement (NSM) during the interval spanning from 2001 to 2002 reveals prevailing accretionary trends across a majority of the examined coastal areas. Particularly noteworthy is the maximum accretion observed, which attains a substantial

magnitude of 160 m. This significant accretion event primarily manifests in the vicinity of structures denoted as C1-SR06-DB, C1-SR7-DB, and C1-SR8-DB, strategically situated within the Negombo beach area. These structures have evidently played a pivotal role in facilitating and augmenting shoreline advancement during the considered timeframe.

Conversely, localized areas of erosion were also identified, with the most extensive erosion registering at -30 m. Furthermore, the analysis unveils noteworthy rates of shoreline alteration. The maximum recorded accretion rate reached 1.86 m/yr, underscoring the dynamic nature of coastal accretion processes. In contrast, the maximum erosion rate was observed at -0.40 m/yr, the inherent vulnerability of certain coastal stretches to erosional forces.

With refer to the figure 7, it can be highlighted that accretion occurred in most of the areas in cell 1 and, noticeable erosion can be observed in the areas where the protective structures are not provided. In comparison to cell 1, cell 2 has been dominated by erosion (Refer figure 8). But accretions can be observed where the structures built, especially from Kelaniya to Uswetakeyyawa stretch. The average accretion 28 m, while the average erosion is -7 m in this stretch. According to the cost calculations, approximately Rs 790 million has been spent for the construction of hard structures from Kelaniya to Uswetakeyyawa. Hence approximately Rs 28.5 million has been spent for 1 m accretion in this region.

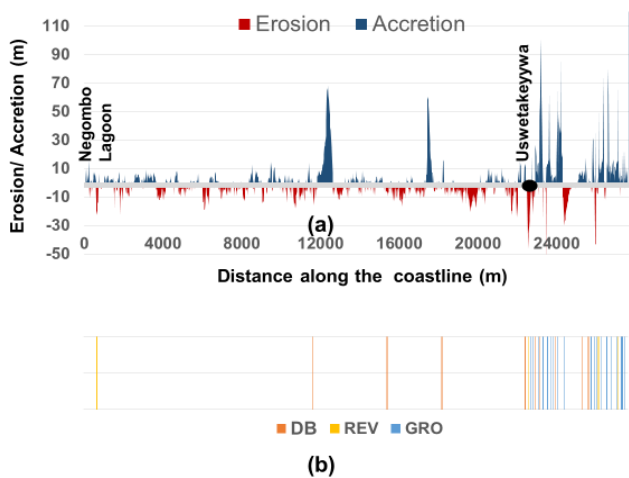
Figure 8: (a) Cell 2-Net Shoreline Movement (NSM) from 2001-2022
(b) Types of structures along the cell 2

Figure 8 shows the results of digital shorelines analysis related to cell 2. In contrast to the observations in cell 1, the analysis of Net Shoreline Movement (NSM) during the period between 2001 and 2002 unveils predominant erosion trends across the majority of the observed coastal regions. Notably, the most substantial erosion recorded reaches -58.7 m, while the maximum accretion measures 102 m. The average erosion value is 6 m, juxtaposed with an average accretion of 10 m. These findings translate into an average erosion rate of -0.35 m per year and an accretion rate of 0.55m/yr.
